# Manhole Inspection Summary

Manhole # S21W\_\_022MH

**Location** Address: **1903 MAISEL ST**

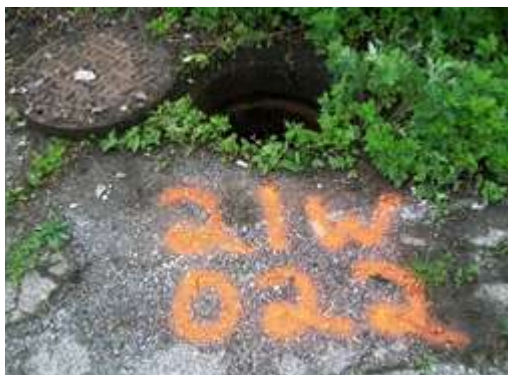
Location View

PAVEMENT MARKED

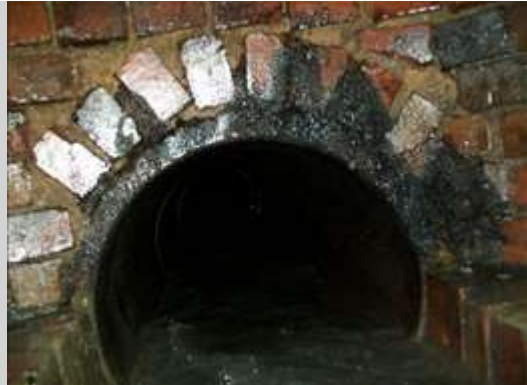
12 O'Clock Outflow

18 in. Circular Gravity Sewer  
Pipe Out @ 12 O'Clock

Pipe Height: **18** (in.) Rod and Bar (Angled)  
Pipe Material: **Clay** ☐ Pipe Lined  
Invert Depth: **14.00** (ft.) Flow Characteristics: **Fast**  
Deposits: ☒ None ☐ Mud ☐ Sludge ☐ Debris ☐ Grease  
Silt Depth: **0** (in.) Deposits Extent:  
Infiltration: **None** Pipe Seal Cond: **Sound**
